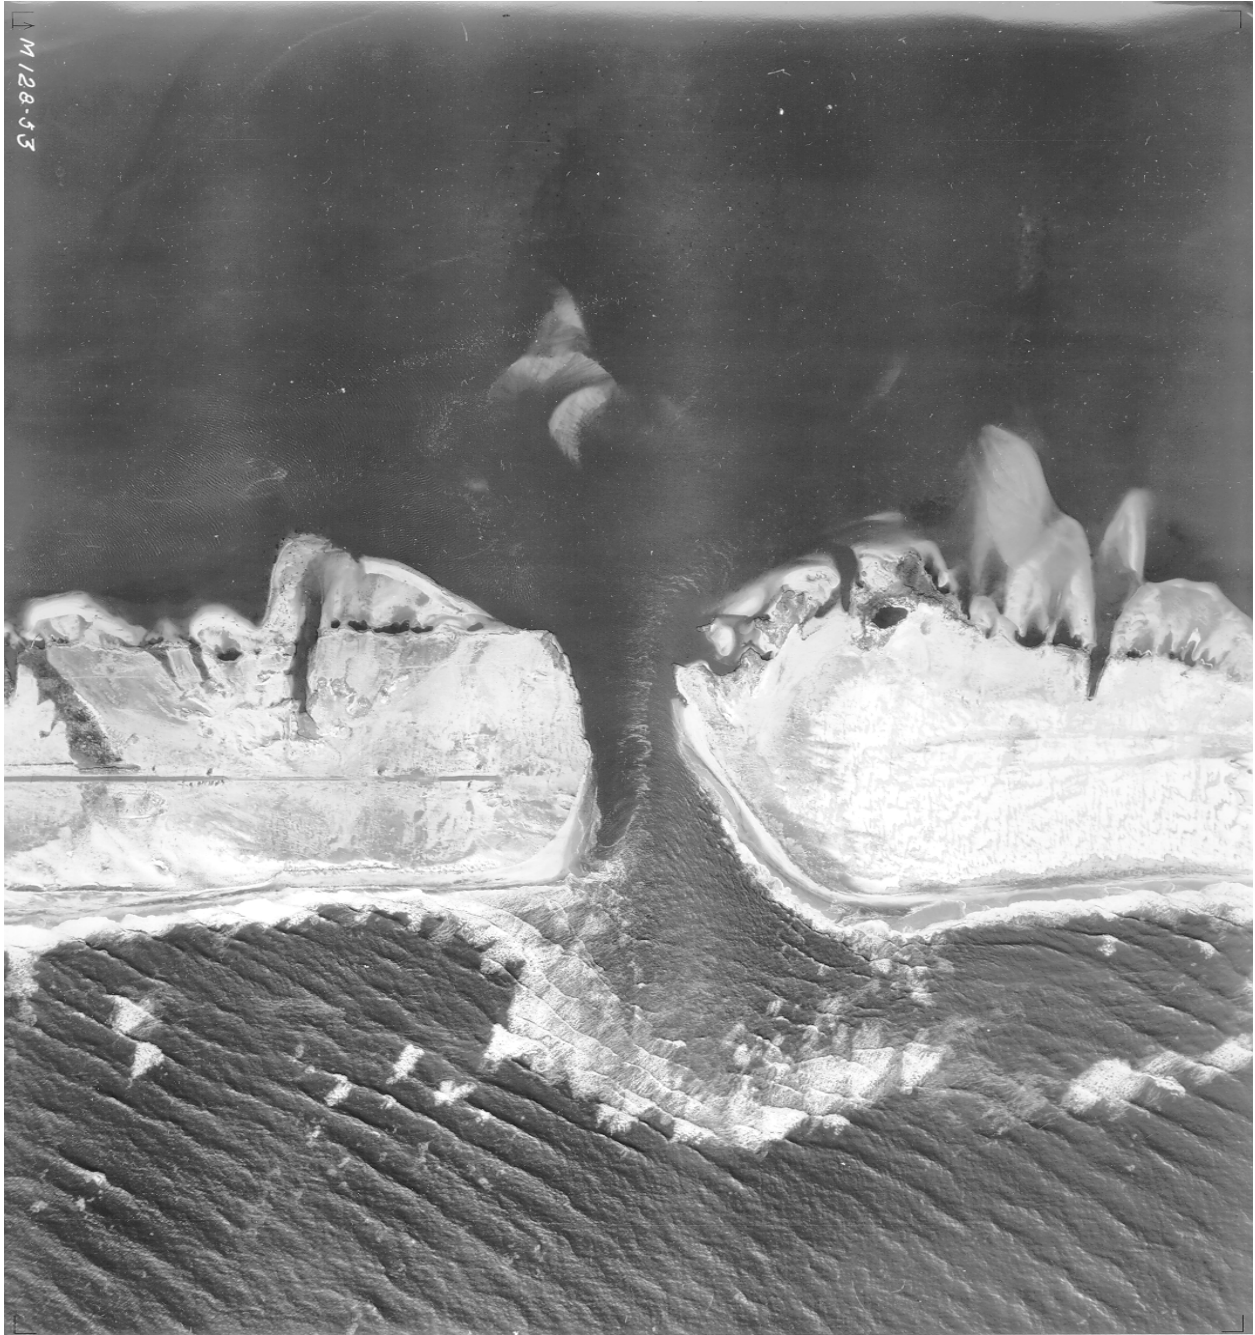
Figure IV-3-27. Shinnecock Inlet, New York, 29 November 1938, photographed only 2 months after the barrier island was breached during the Great New England Hurricane of 21 September 1938. North is to the top of the image. The body of water to the top is Shinnecock Bay, and the Atlantic Ocean is on the bottom. The inlet already displays an oval ebb-tidal shoal. A small shoal in Shinnecock Bay indicated development of a flood shoal. Washover fans, remnants of the storm, can be seen on both sides of the inlet. (Photograph from Beach Erosion Board archives)
